FOURTH ENDORSEMENT on VP-24 AAR ser 2-52 of 21 Oct 1952

Subj: Aircraft Accident Report P4Y-2B BuNo. 59988

THIRD ENDORSEMENT on VP-24 Aircraft Accident Report serial 2-52

SECOND ENDORSEMENT on VP-24 Aircraft Accident Report serial 2-52

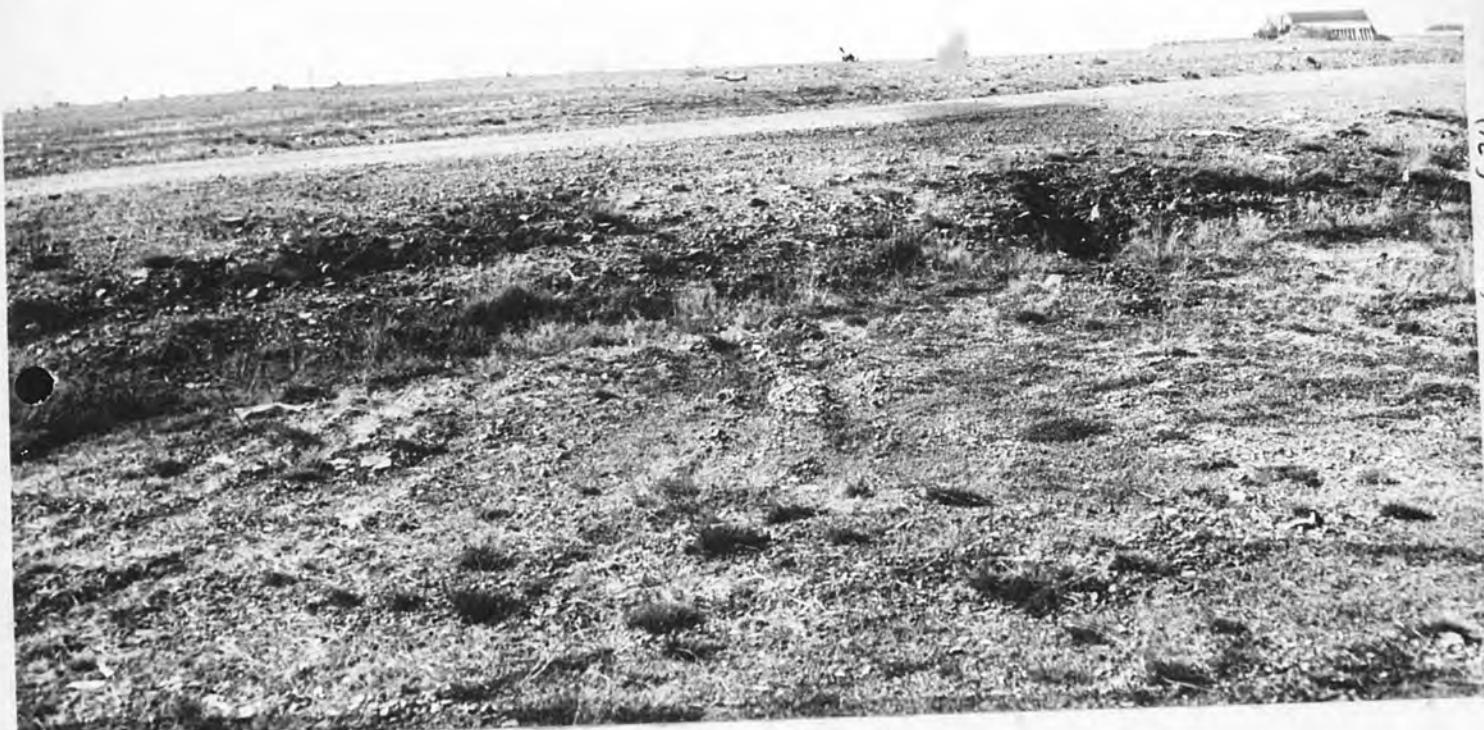
- (30.) The first damage to the aircraft occurred at the initial point of impact 548 feet short of runway 25, Enclosures (15) and (22). At this point the port wing hit the surface of the elevated road followed almost immediately by the propellor of the number one engine, Enclosure (20). The port main gear struck the ground 15 feet short of the elevated road and continued into the side of the road bed, Enclosure (21). The impact at an estimated speed of 125 knots and an angle of approximately 5 degrees produced unknown damage to the port wing tip and bending the propellor blades causing the propellor and nose section of number one engine to shear off. The propellor struck the ground 130 feet from the impact point and came to rest 65 feet from the approach end of runway 25, Enclosures (23) and (24). After hitting the roadbed the port main gear oleo was sheared spraying hydraulic fluid across the road, Enclosures (25) and (26), and the broken main gear piston dropped out shortly thereafter, Enclosure (27). The port main gear hanging by the drag strut broke loose and came to rest as indicated in Enclosures (28), (29), and (30) after bouncing down the runway, Enclosure (31) (32). A portion of the port landing flap, Enclosure (33), was torn off by the port main gear when it broke loose and came to rest about 250 feet from the end of the runway, Enclosure (16). The port wing tip again struck the ground about 200 feet from the end of the runway and dragged along the ground striking the outboard starboard threshold light, Enclosure (34). The plane continued in an arc across the runway in an increasing bank to the 1 ft dragging the port wing tip, Enclosure (16). At the time the plane left the runway, 430 feet from the beginning, along the port edge, it was in a vertical bank missing a high intensity light by 3 $\frac{1}{2}$ feet, Enclosure (35) and (36). The aircraft became inverted and collided nose first with the ground 150 feet from the port edge of runway 25, Enclosure (37). At this position the engines were thrown from their mounts directly ahead of the aircraft. Plexiglass from the bow turret dome, Enclosure (38), and the positions of the engines indicate that the aircraft was inverted upon colliding with the ground, Enclosure (17). The airspeed is estimated at 110 knots and the angle of impact at 45 degrees. The momentum at this impact then caused the aircraft to fall over on the ventral side righting itself again striking the ground but with the fore and axis now approximately 130 degrees to its former path of travel, Enclosure (17). From this position the entire aircraft slid sideways separating in three sections; the flight deck, the wing section, and the tail section, Enclosures (18) and (40). The flight deck section came to rest approximately 135 feet from the second major impact position and 130 degrees to the path of travel, Enclosures (41), (42), and (43).

CONTACTS MADE BY VARIOUS PARTS OF PLANE AT INITIAL IMPACT ALONG ROAD.

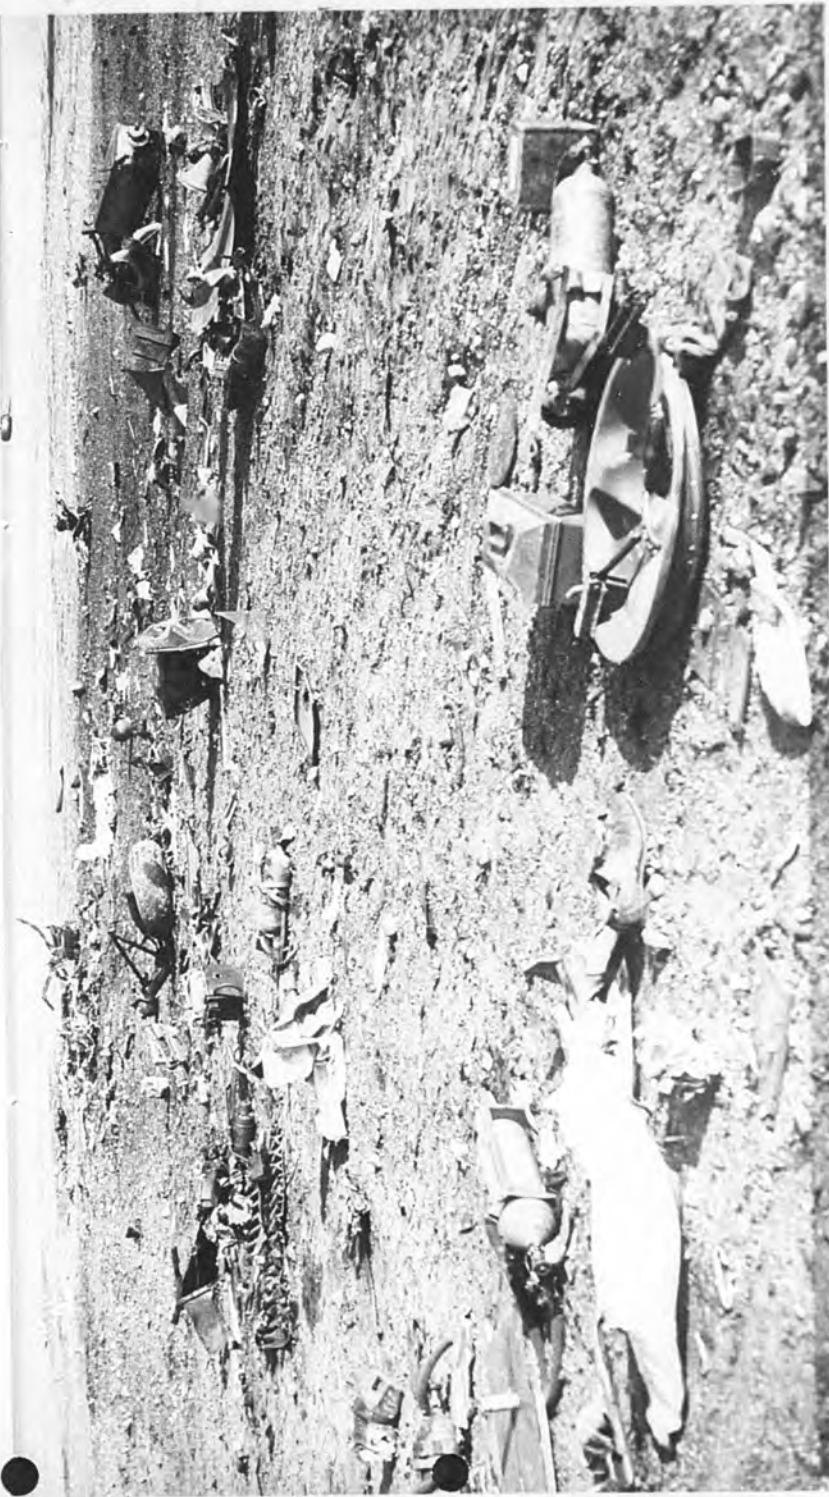
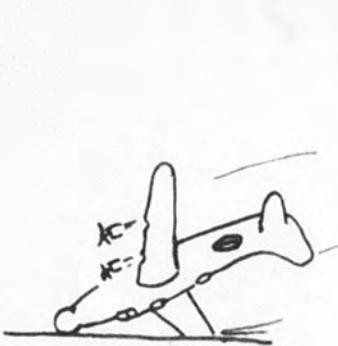
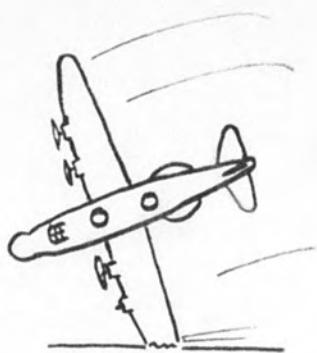
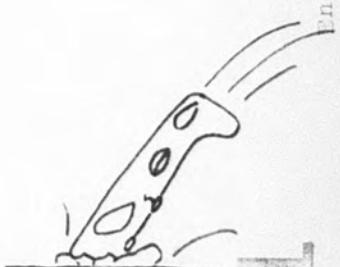
Inclosure (39)

The raised roadbed at the initial impact point caused considerable damage to the aircraft. When the plane collided with the embankment the number one propeller, the port mount, and the port flap were removed. Due to the damage rendered by this impact the aircraft was without sufficient control to recover upon the addition of power by the pilot. The thrust developed by the starboard engines was considerably greater than the thrust developed by the port engine and the removal of the port flap resulted in a loss of lift to the port wing. With greater thrust being produced on the starboard side and the loss of lift to the port wing the aircraft made an increasing banking turn to the left scraping the portwing and continuing on over to a slightly inverted position. The aircraft being slightly inverted when the power was cut struck the ground in a nose low position. Forward momentum carried the aircraft over whereupon it collided with the ground in an upright position, then separated into three major sections, Enclosure (39).

SKETCH OF AIRCRAFT ATTITUDES BETWEEN SECOND IMPACT AND POINT OF
BREAKUP INTO THREE MAJOR SECTIONS

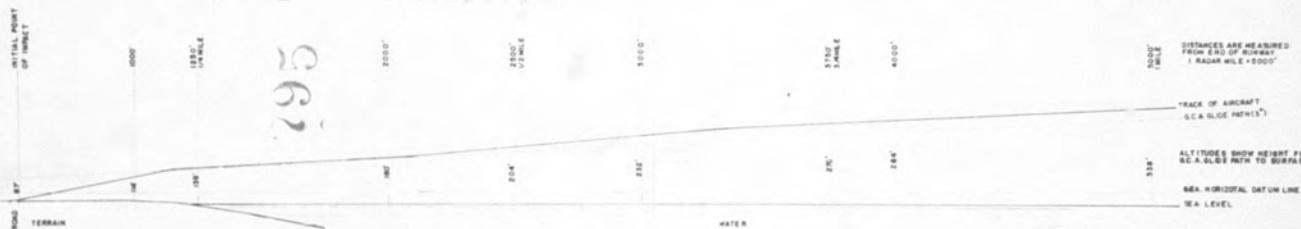
APPROXIMATE GLIDE PATH OF
P4Y-2B 599H8 AS DETERMINED
FROM GCA TRANSCRIPTION
